Alliance YMCA - Water Heater Replacement

HEI Engineering Group completed a boiler and water heater replacement at the Alliance YMCA in Alliance, Ohio. The existing boiler and water heater were failing and needed to be replaced. A limited amount of space in the room and a minimal amount of time allowed for shut-down were factors on a new layout.

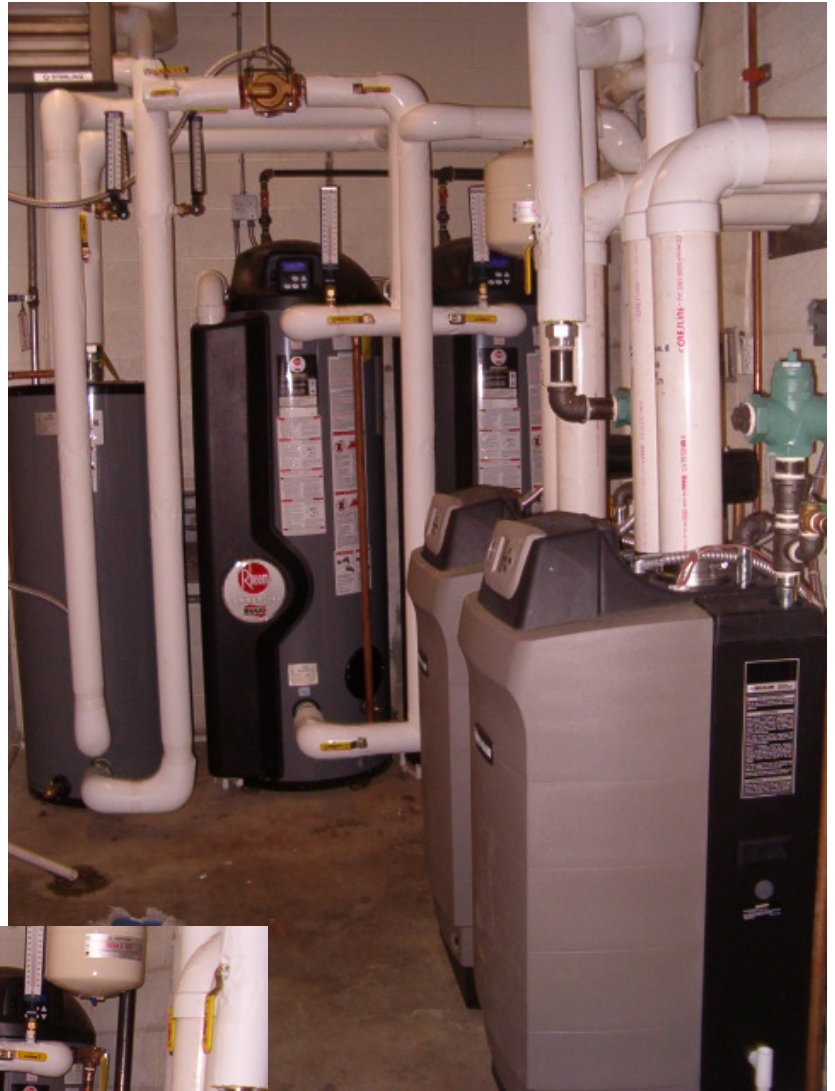
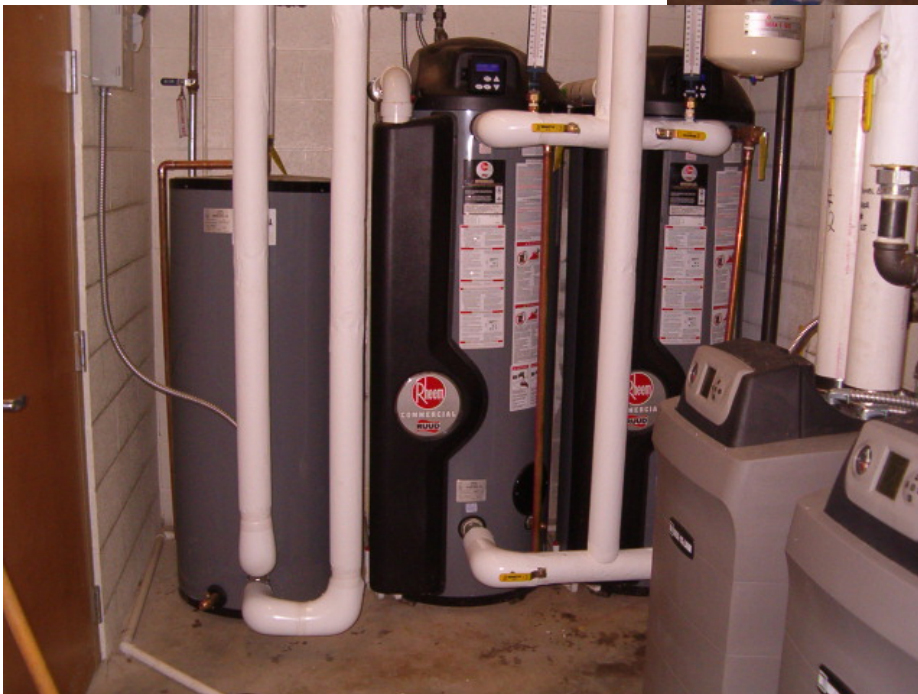
Two new high efficient water heaters and a storage tank were installed for the domestic water heating. This would allow isolating systems if one of the water heaters or storage tank needed service or failed and still be able to maintain hot water for the showers and locker rooms.

Two new high efficient instantaneous gas fired boilers were installed for the heating system that included the heating coil for the Dectron unit serving the pool. This design helped maintain a small footprint in the space and allowed maintenance access to all of the equipment.
